COUNTY OF LANCASTER, PA COUNTY COURTHOUSE DOME

CONDITIONS ASSESSMENT

Summary Presentation

19 November 2014

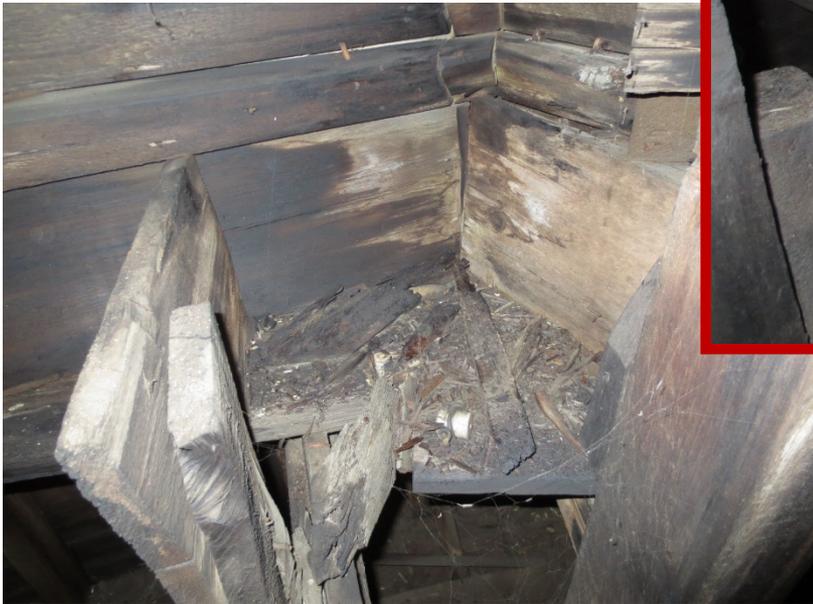
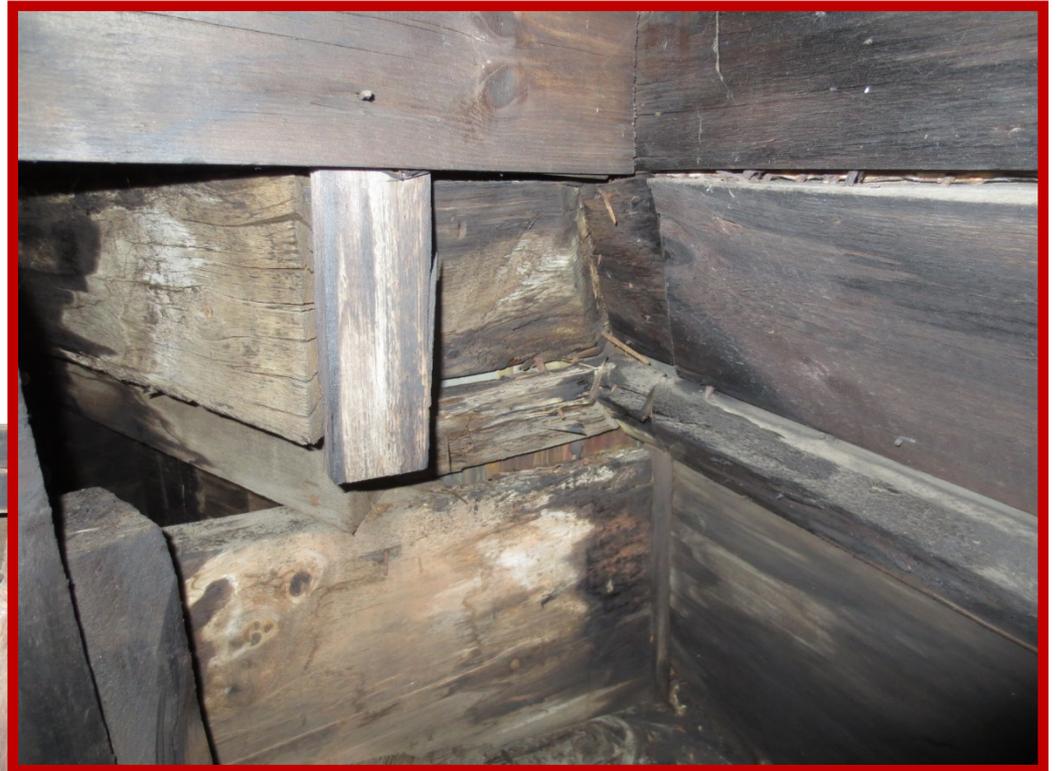
Deteriorated Wood Deck

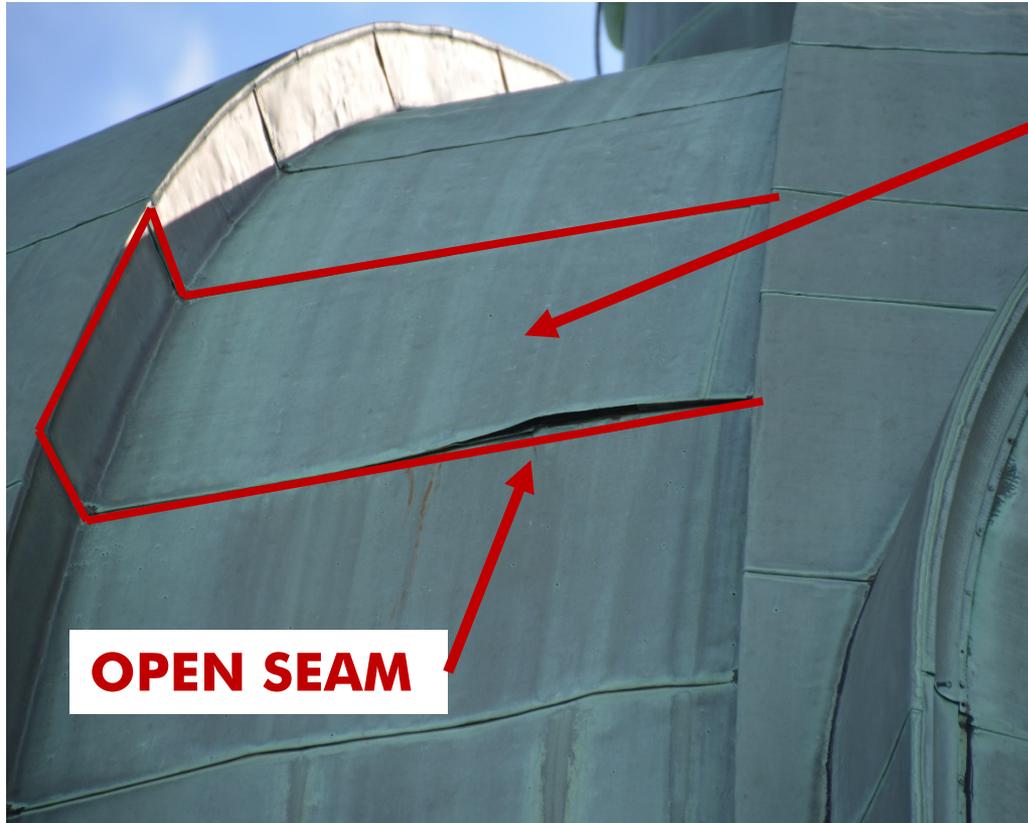
OPEN SEAM

*The copper pans
on this roof are
2-3 times larger
than they should
be for this type of
roofing system.*

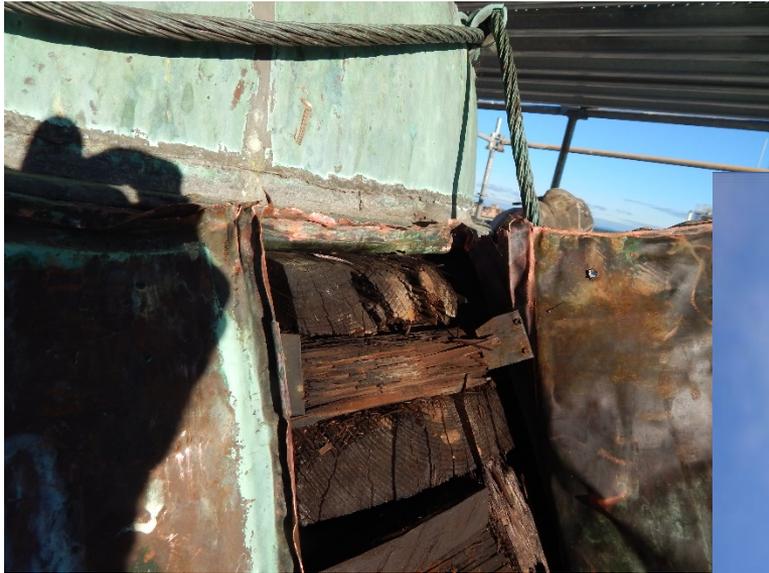
**Water infiltration
at base of Statue**

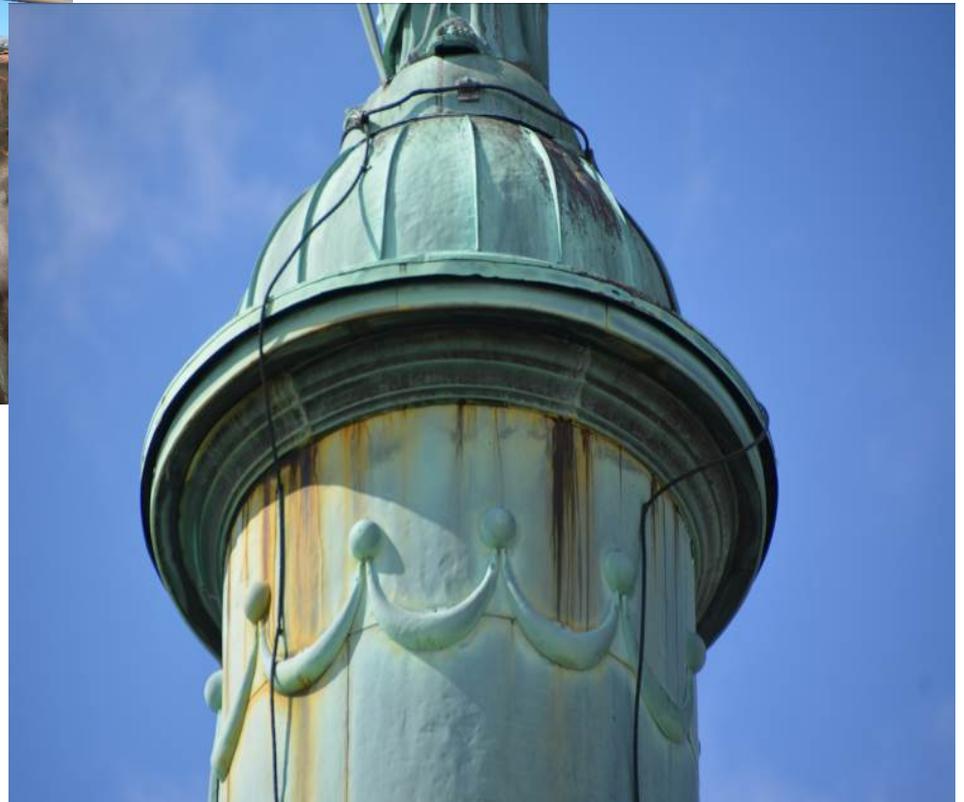
**Rust staining
on Cylinder**

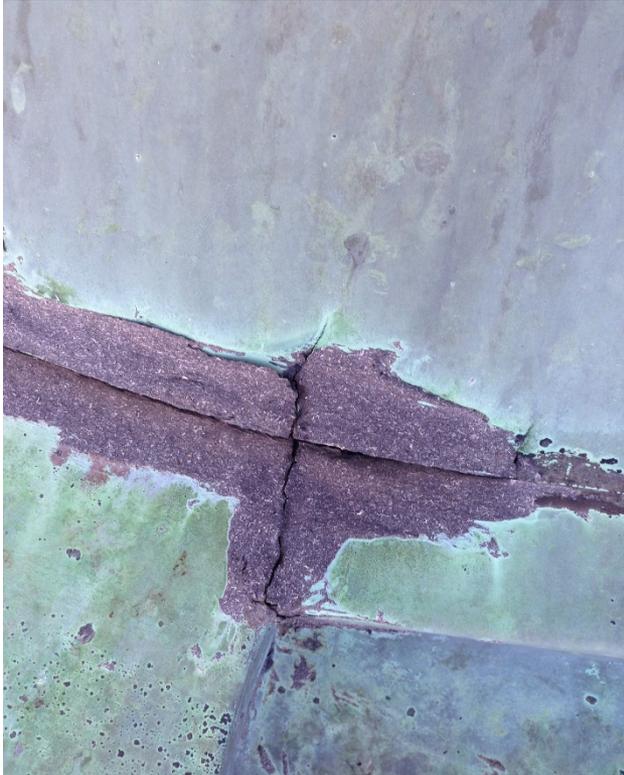
FAILED REPAIRS

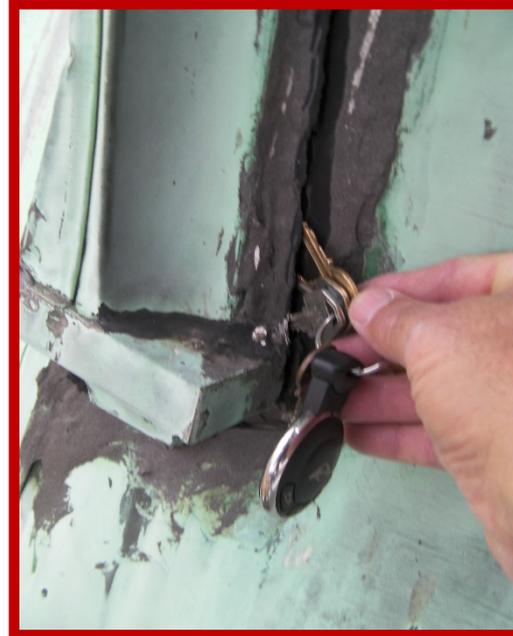
OPEN SEAMS

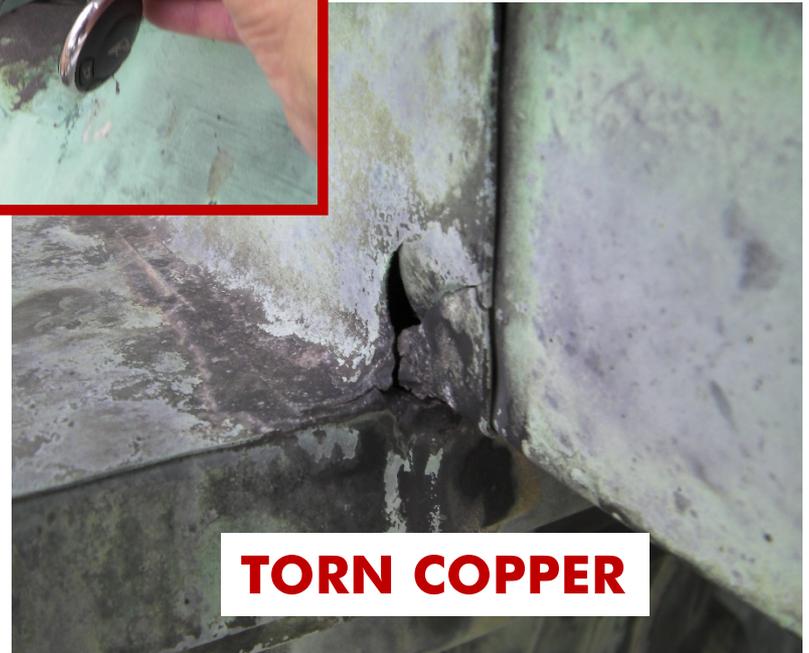
TORN COPPER

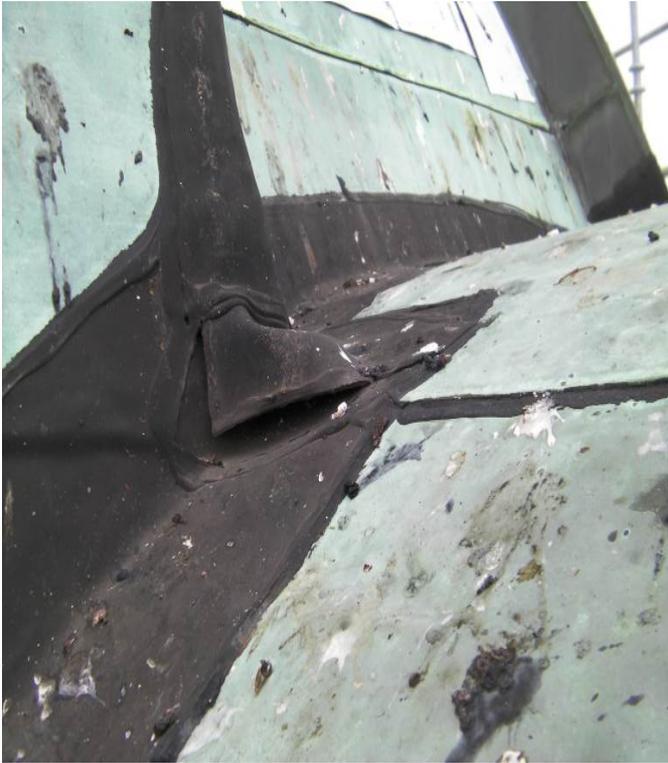
FAILED REPAIRS

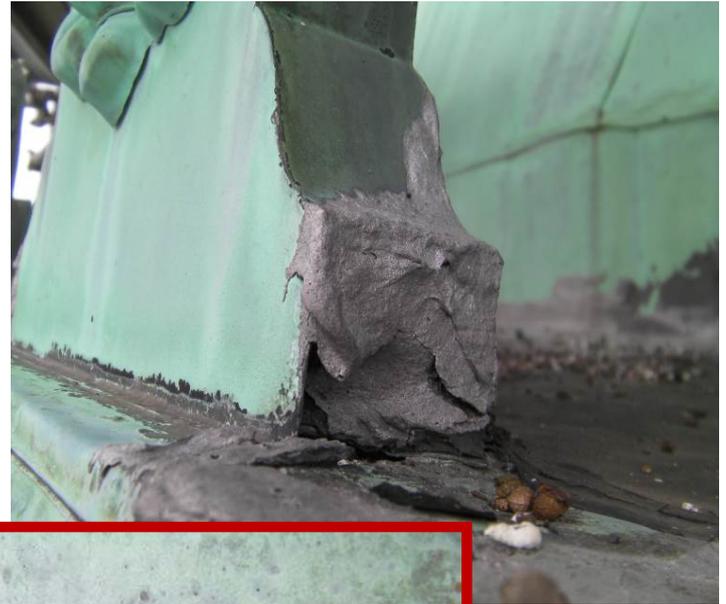
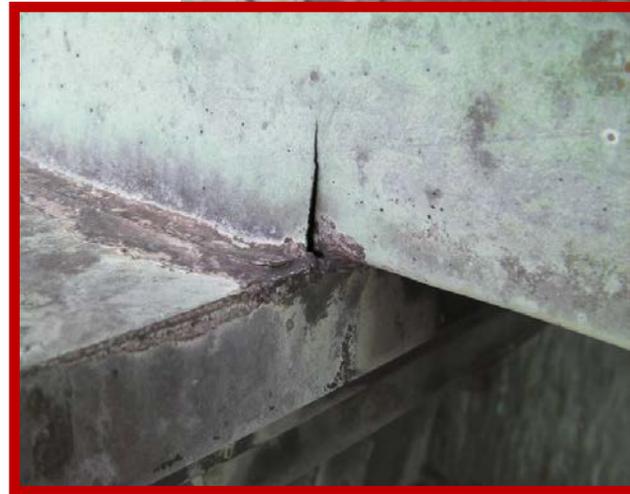
TORN COPPER

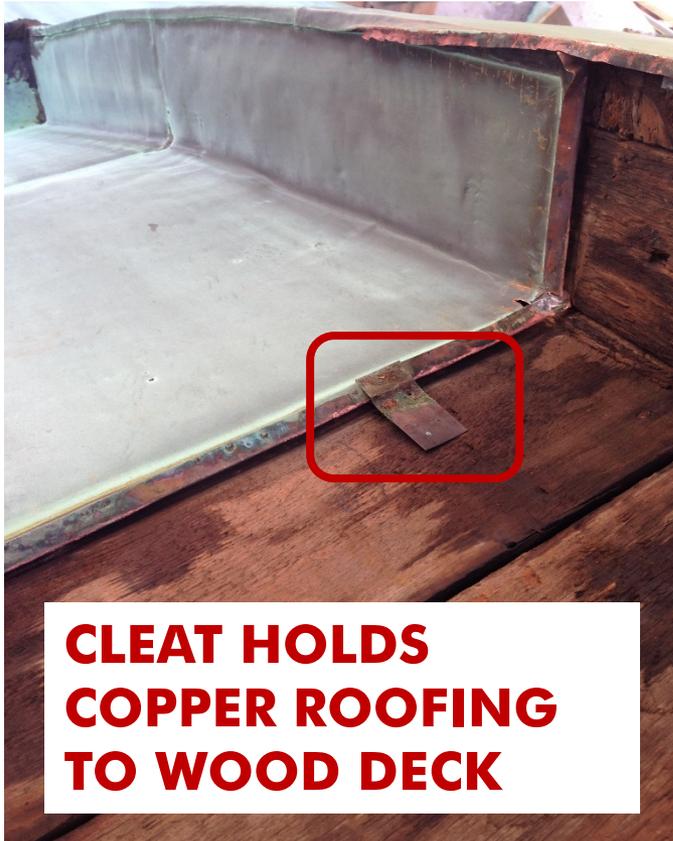
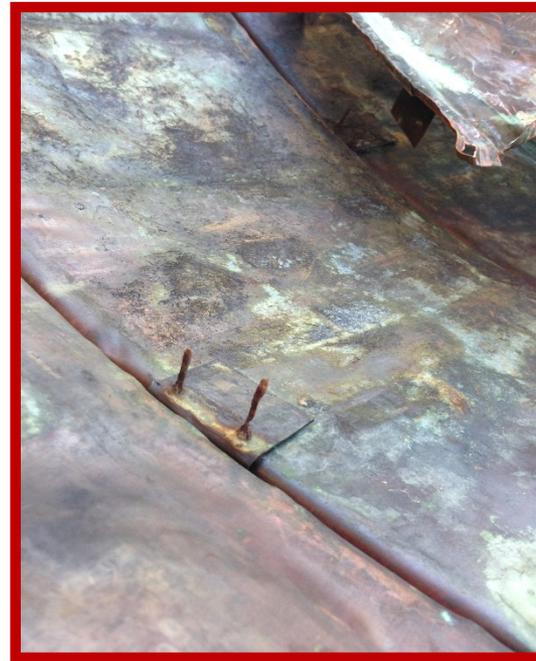
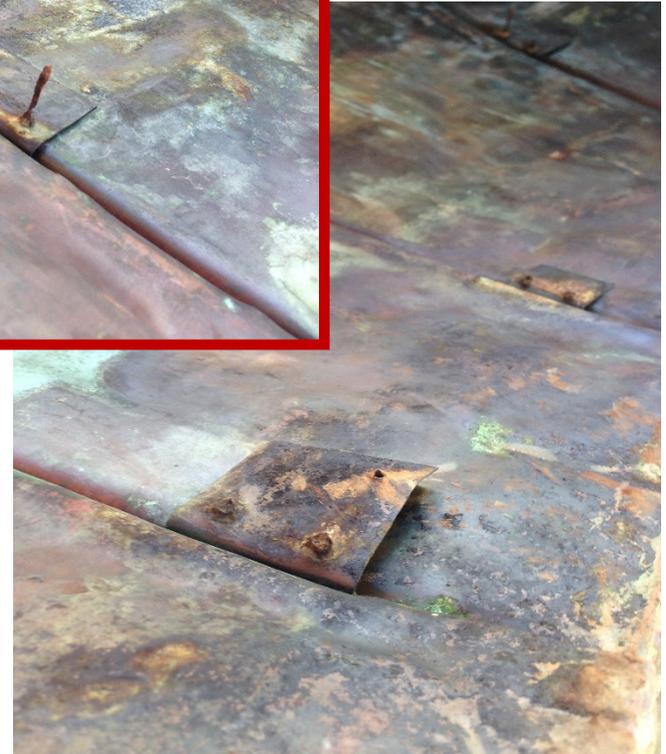
CLEAT NAIL DETERIORATION

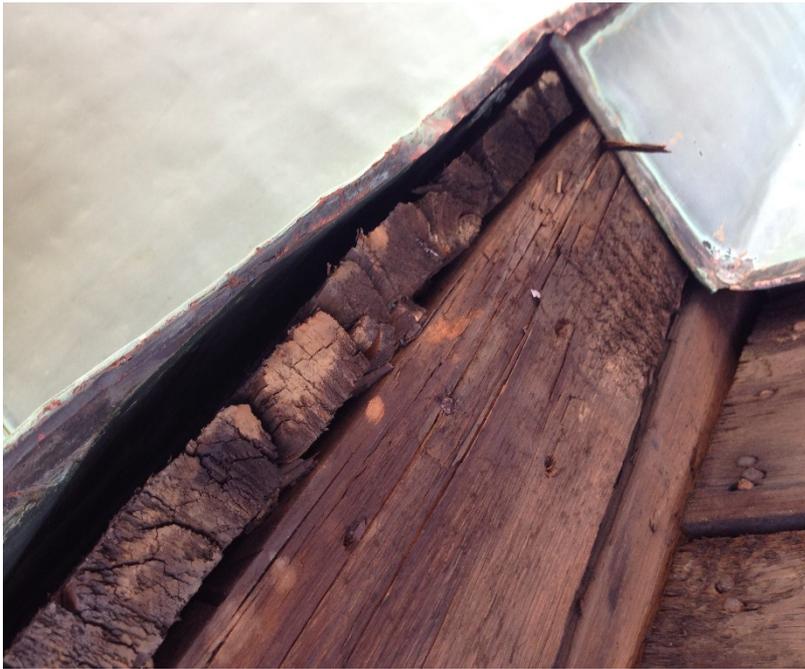
ROTTED WOOD DECK

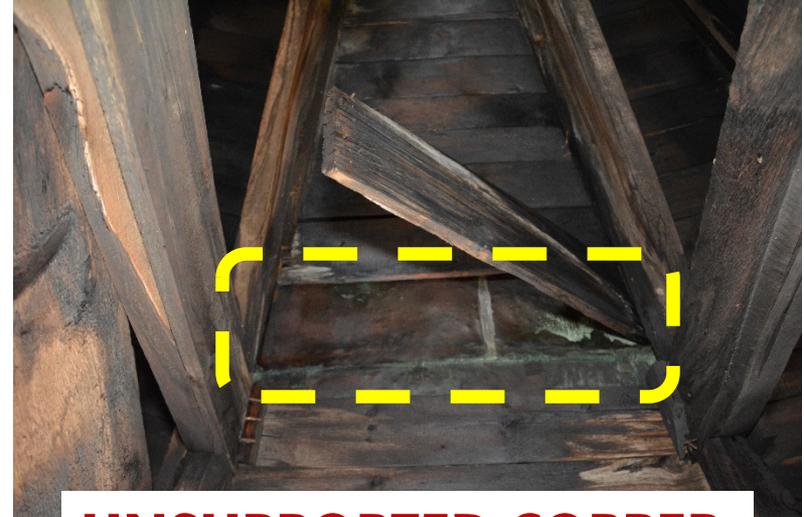
UNSUPPORTED COPPER

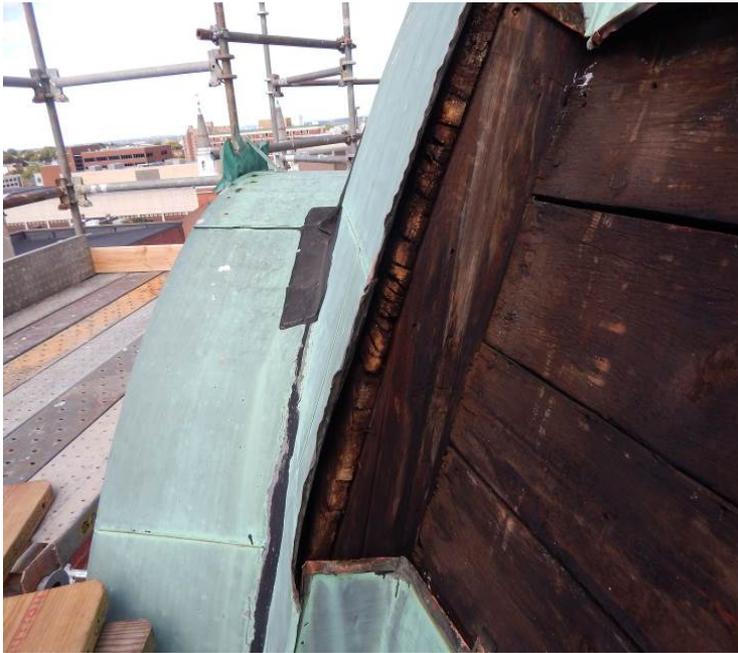
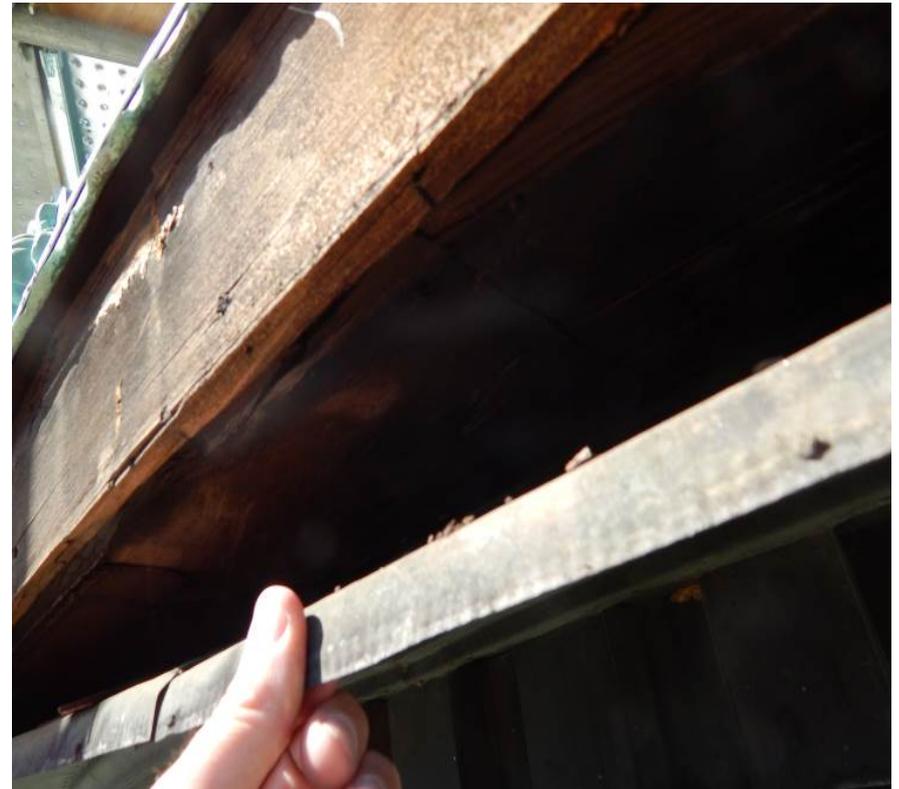
ROTTED WOOD DECK
