COUNTY OF LANCASTER, PA COUNTY COURTHOUSE DOME

CONDITIONS ASSESSMENT

Summary Presentation

19 November 2014

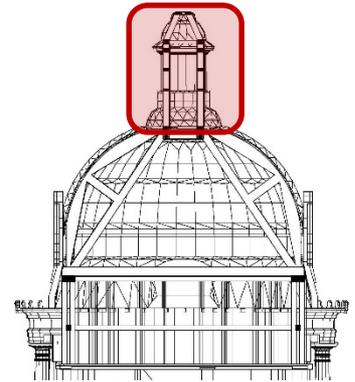
Minimally invasive.

Corrects only some of the observed failures.

Leaves many defects in their current condition.

Is not a long-term solution.

***DOES NOT ADDRESS THE PRIMARY DEFICIENCIES
ON THE MAIN DOME AND LEDGE***

- ✓ Remove and rebuild the Cap structure and deck
- ✓ Repair the wood on top of the Dome Compression Ring
- ✓ Replace decking on Cylinder
- ✓ Install new copper roofing on Cylinder and Cap
- ✓ Reinstall Lady Justice with new base-to-Cap detail to mitigate water infiltration
- ✓ Replace missing fasteners in ornamental copper components

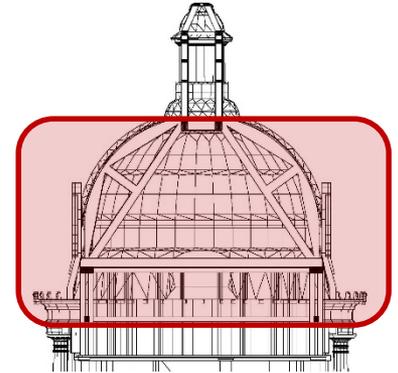
Correct the problems and failures that we have observed.

Provides watertight roofing system.

Expands on the corrective work in Option 1 by:

- ✓ Removing the remaining copper from the Ledge soffit to the top of the Dome
- ✓ Either repairing/refastening or replacing all of the wood decking
- ✓ Repairing framing damage to structural members and deck supports
- ✓ Repairing/rebuilding the entire Ledge structure including the soffit, fascia and decking
- ✓ Installing waterproofing membrane/underlayment over the entire structure
- ✓ Installing new copper roofing system to meet modern performance standards
- ✓ Replicating, as needed, and reinstalling all of the ornamental copper
